Concrete Problems Today Are Multifactorial – Root Causes

BY HAMID KHAN

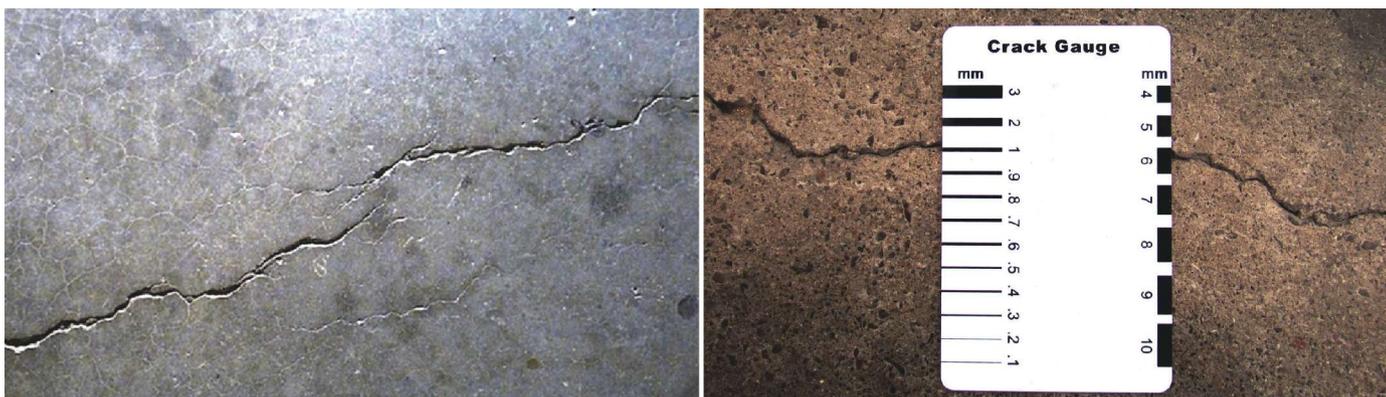
Concrete cracks provide easy access to corrosive agents

Corrosion of the steel generates iron oxides and hydroxides, resulting in an increase of volume 5 to 8 times of its original size. This increase in volume causes expansive forces to accumulate within the concrete around reinforcement and results in cracking, and in areas with low cover, concrete spalling. Cracks provide

easy access to oxygen, moisture, chlorides, and other corrosive agents that create conditions suitable for accelerating the electrochemical corrosion process. Pretensioned concrete bridge girders may exhibit unexpected end cracking upon stress release. These cracks may propagate into the bottom flange of the girder where strands are located and can increase in width with increased traffic loads. Leakage from a bridge expansion joint could penetrate the bottom flange cracks and trigger severe corrosion. In this case, expansion joints leakage must be arrested prior to the crack and concrete repair activity.

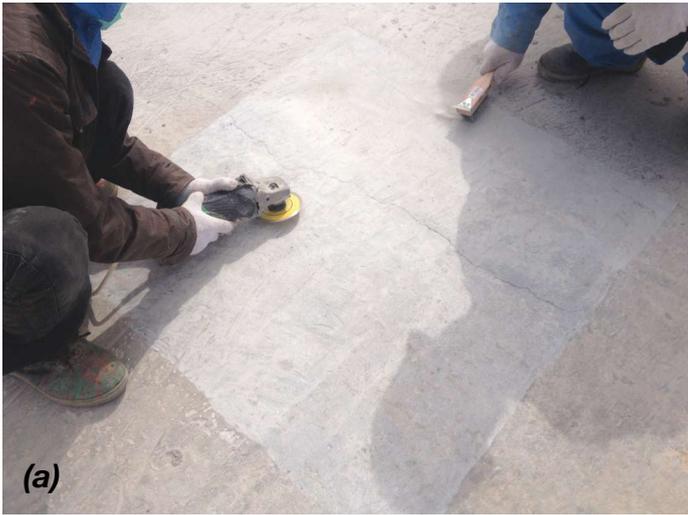
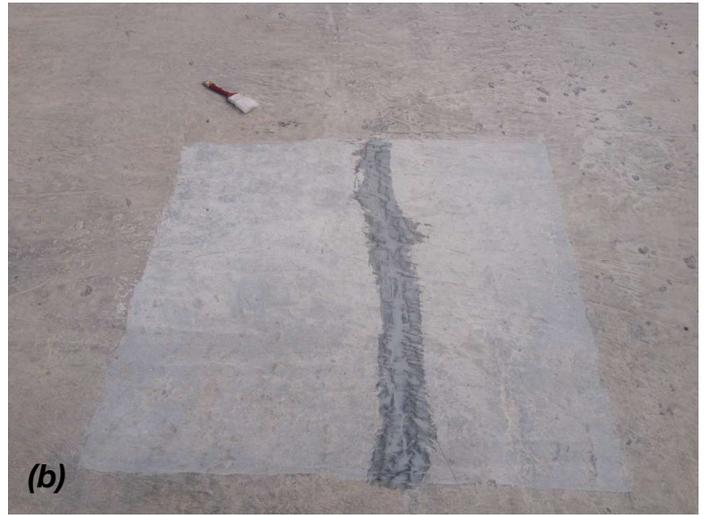
Linear transverse cracks on new bridge deck due to plastic shrinkage—surface grinding to open the face of the crack (a) and sealing with epoxy (b)

A common form of cracking at an early age on new concrete decks is known as *transverse cracking*, which may appear over the length of span above transverse reinforcement. These cracks can accelerate corrosion rates, reduce the service life of the asset and increase maintenance costs. When a mass of concrete that shrinks as it ages is restrained, cracks will occur. For example, restraint of a concrete deck by an integral support girder against its volume change initiates cracking. Multiple factors such as concrete materials and mix design, ambient temperature changes, humidity, bridge design characteristics, and construction practices can all contribute to volume change and/or to the degree of restraint of concrete mass. However, transverse cracking cannot be attributed to all of the above factors. It is therefore important to identify the major contributing factor(s) to address the root cause of cracking.

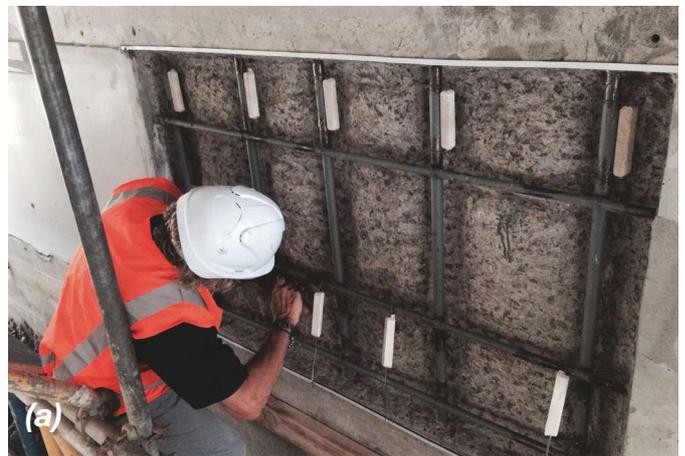
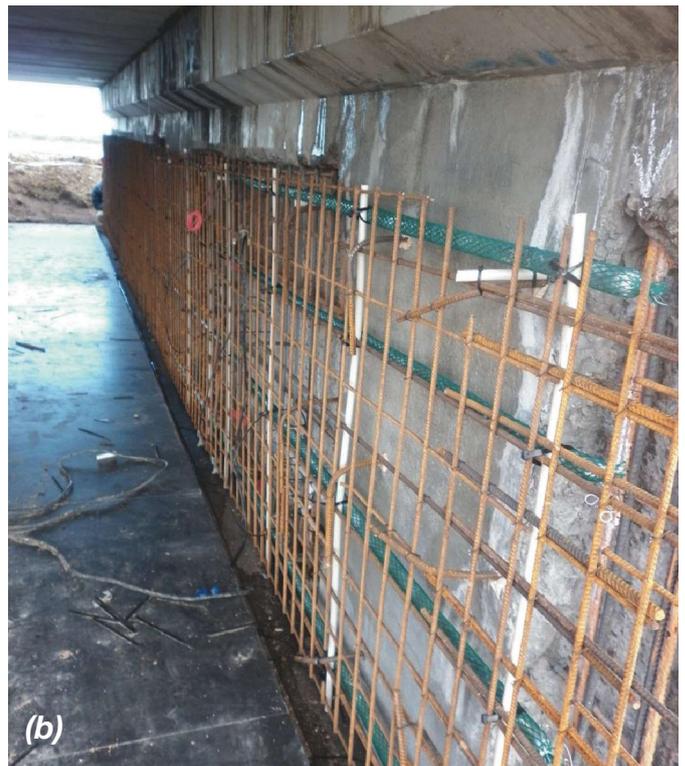
Cathodic protection to bridge piers affected by cracks, corrosion, and spalled concrete, using embedded galvanic anode units (a) and distributed galvanic anode system (b)

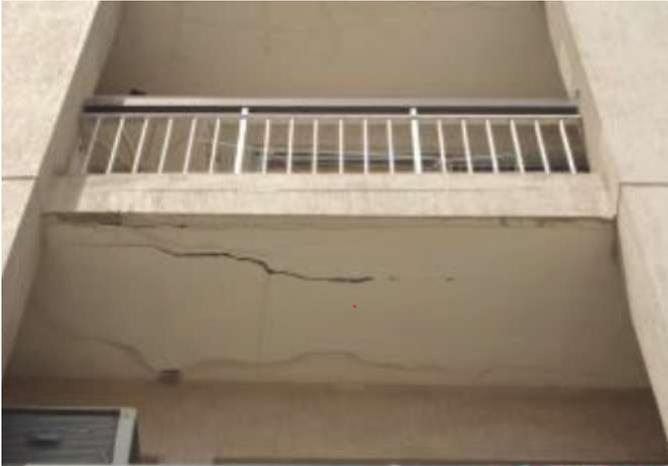
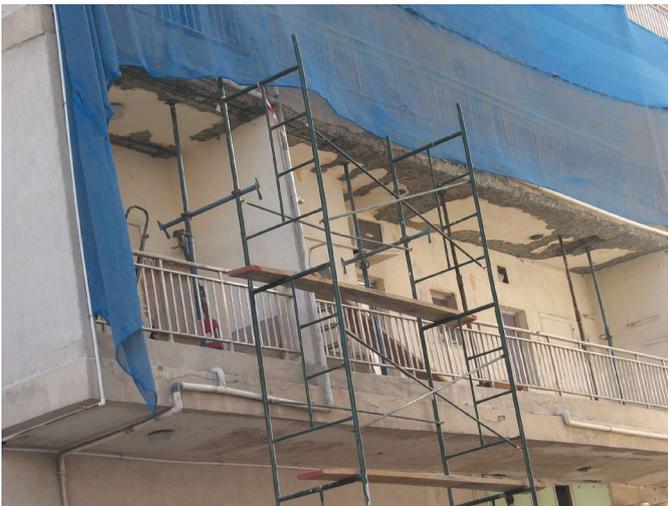
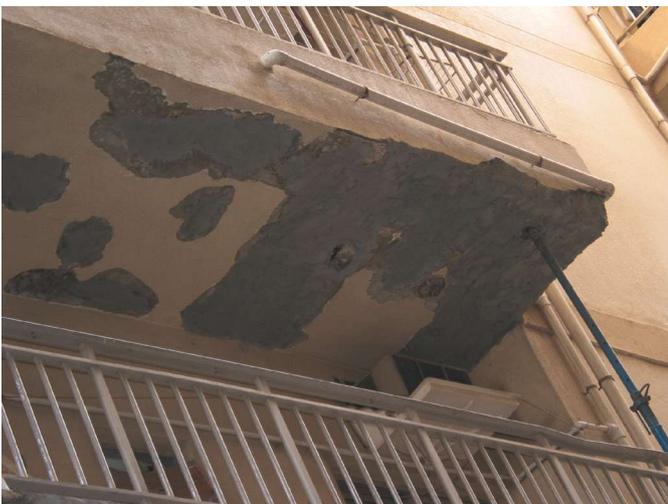
Repair of balcony concrete corrosion and spalling due to multiple factors

Concrete repairs conducted without considering the actual source are cosmetic repairs and may last only for few months. For instance, repairing the spalled concrete of a balcony with a quick-fix patch method, and even applying the best quality repair mortar, would not solve the problem unless the root cause has been identified and addressed. It could be attributed to more than one cause such as leakage due to failure of waterproofing membrane, a broken drain pipe, leaking concealed pipe joints or a combination of these factors. Corrosion of reinforcement that has caused spalling of the balcony is not the root cause here.

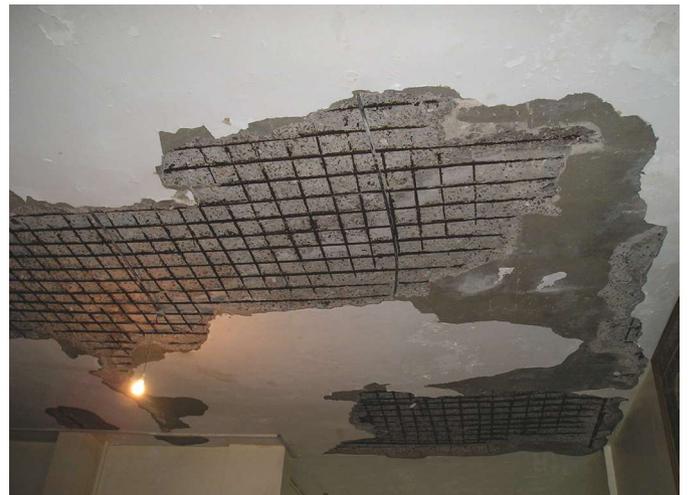
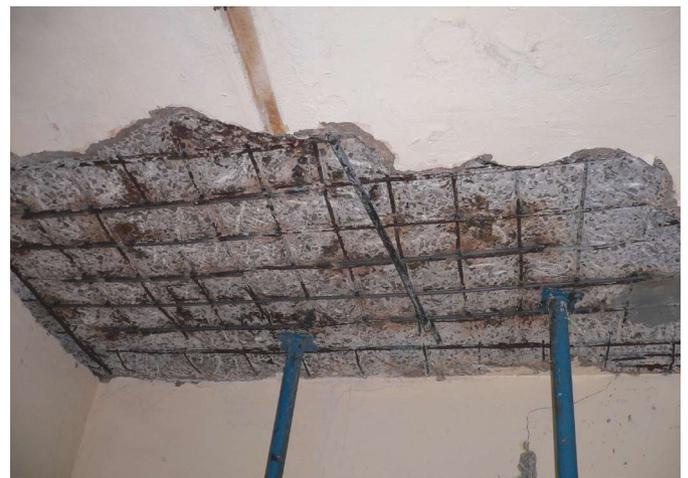
Soffits severely corroded due to roof leakages into a residential building

Roof leakages in buildings result in seepage into the rooms below. This causes discomfort to the occupants and frequent disputes between the landlord and the tenant in regard to the liability for repair. The failure of roof waterproofing is often attributed to poor workmanship. Based on this notion, the roof refurbishment

is carried out but the leaks appear again after some period of time. Research conducted by Lo, Leung and Cui (2005)² on roof construction defects has highlighted that the root cause of failure of the roof waterproofing membrane stems from the roof parapet wall cracks. It further concluded that the design and choice of material for a roof parapet wall is critical to avoid waterproofing membrane failures on the roof slab. Other reasons for roof leakage could be wrong termination details of the waterproofing membrane at up-stands and drains, improper selection of the waterproofing system, and poor roof joint detailing.
